MASTER PLAN for FORT BARTON

TIVERTON, RI

EXISTING CONDITIONS

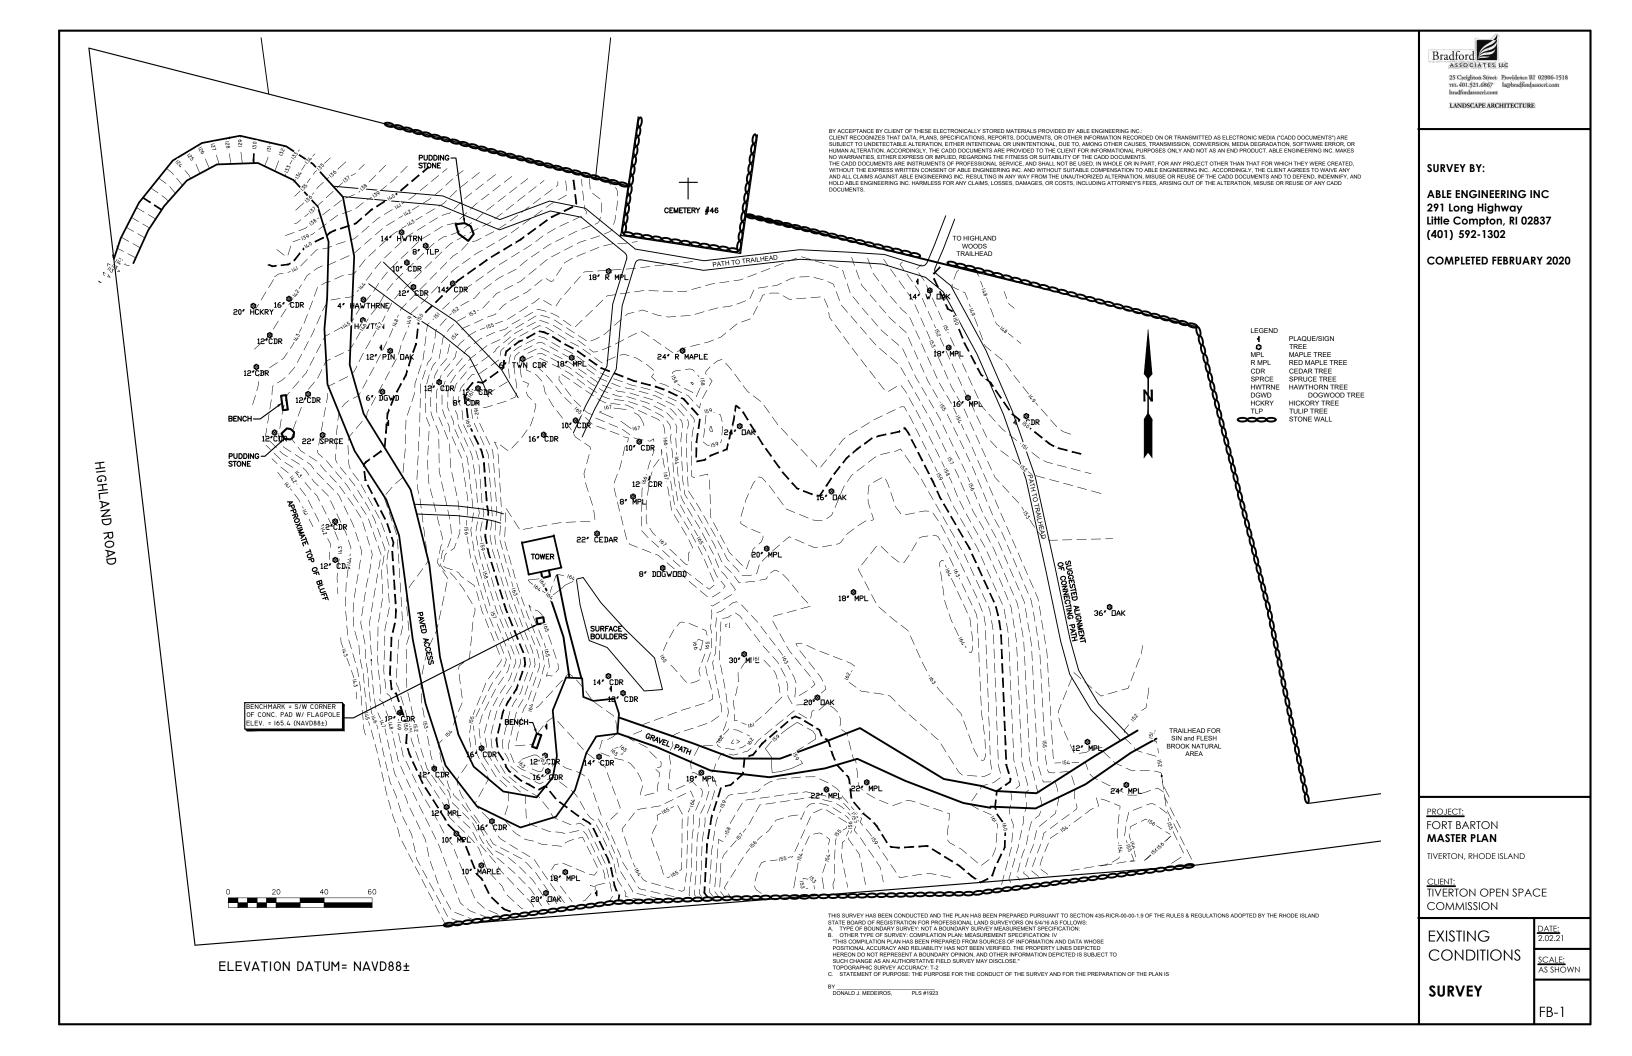
** See Plan 'FB-1 Survey'

Individual large trees were located by the surveyor. Species were confirmed and additional smaller trees added to the Tree Inventory sheet, Plan FB-2. Formal and informal circulation routes are also shown.

This information, including topography, major trees, observation tower, paths and driveway, is the basis for master planning decisions to protect the historic fort remnants through compatible land use and site management.

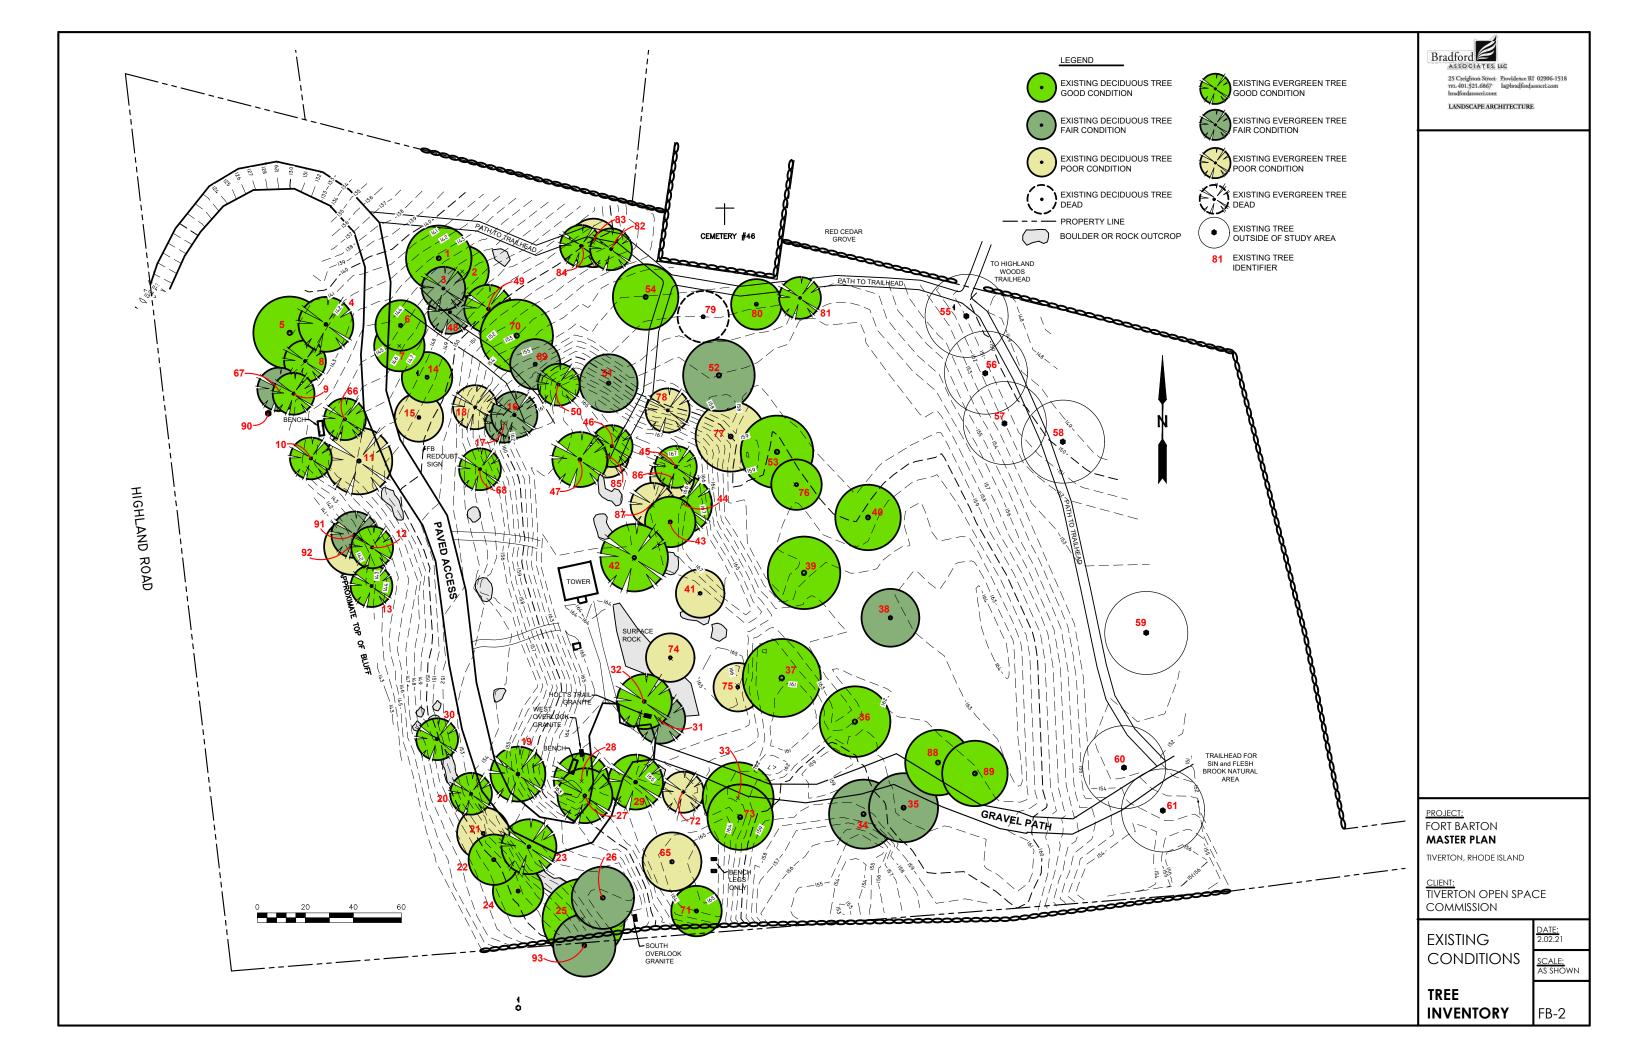
** See Plan 'FB-2 Tree Inventory' and 'Appendix'

Major trees are plotted on the *Tree Inventory*, Plan FB-2, and tree conditions with associated data are recorded in the *Appendix - Tree Inventory*, beginning on page 12. The general ratings used for tree health and structure are as follows:

Trees have a major impact on the landscape character of the fort area. The locations of evergreen vs. deciduous trees, as well as their condition and size are important in assessing view corridors and management decisions. Poor condition trees and smaller ones may be a priority for removal to improve views or circulation.

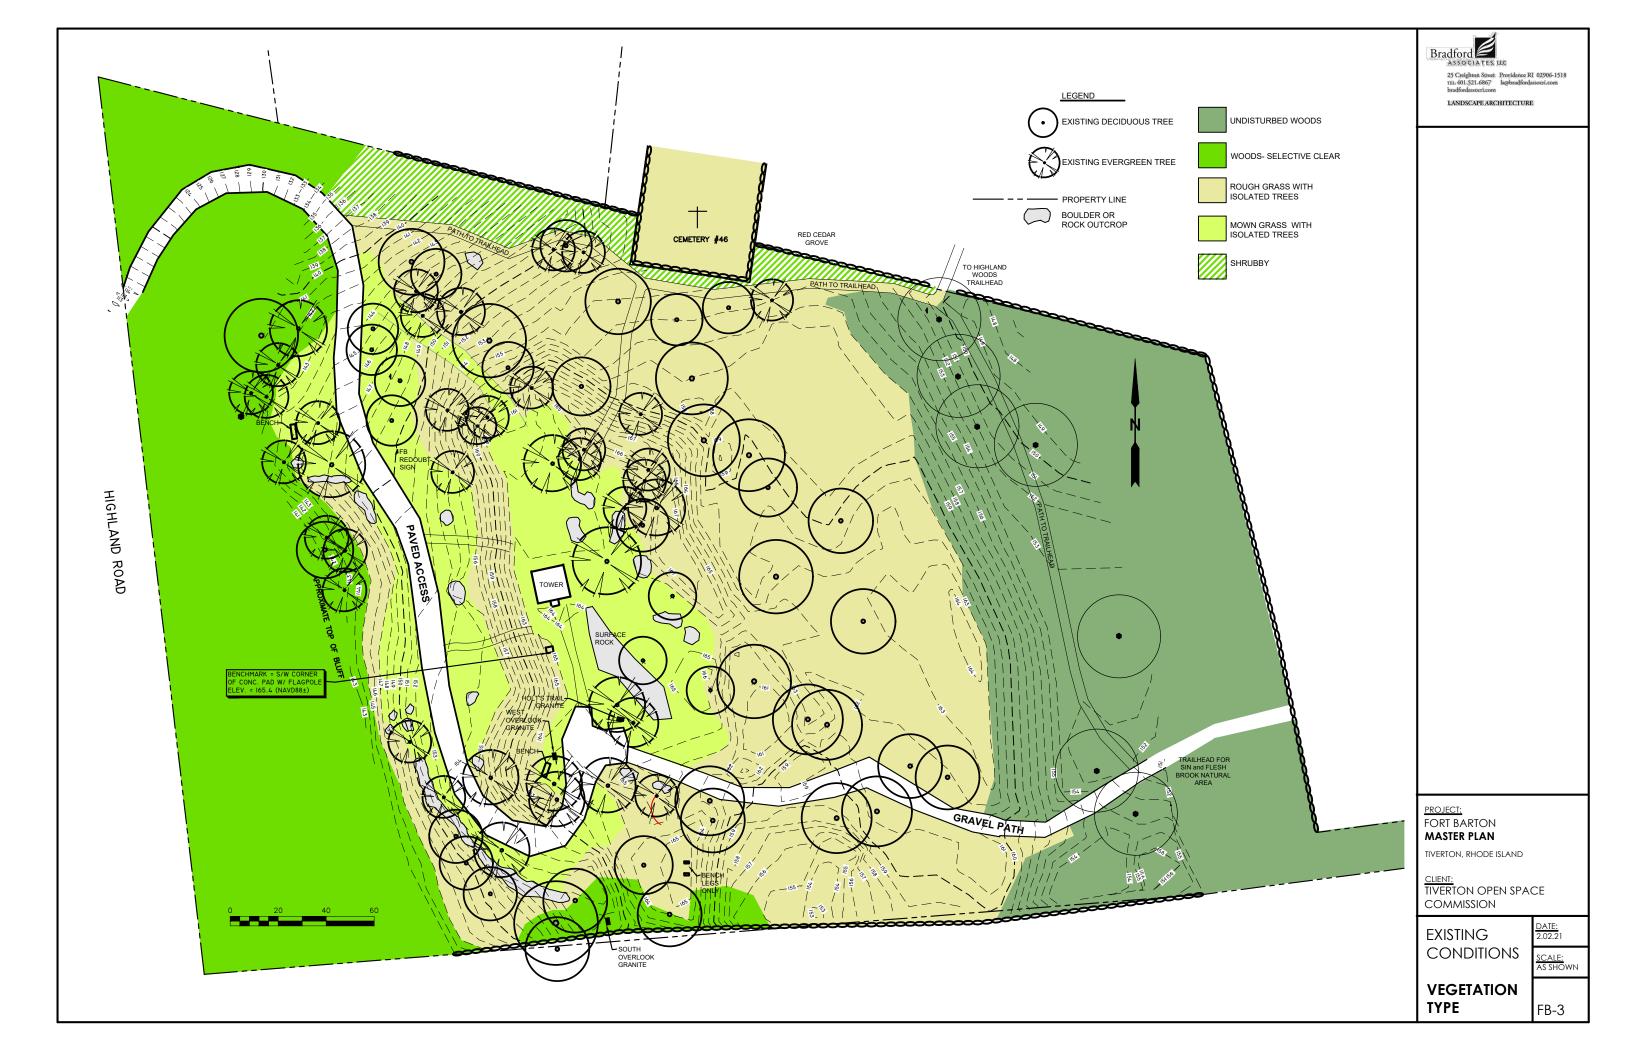
** See Plan 'FB-3 Vegetation Type'

The *Vegetation Type Plan* documents general categories of vegetation on site and thus describes landscape character and its current management.

An important element of master planning for the site will involve vegetation and long-term protection of the fort earthworks. Plans should encourage desirable use of the site while considering available resources. Much of the area is now rough grass, a category with a range of growing conditions and uses. As planning proceeds strategies will be developed for stewarding both the sensitive slopes of the redoubt and the surrounding low maintenance, limited use areas.

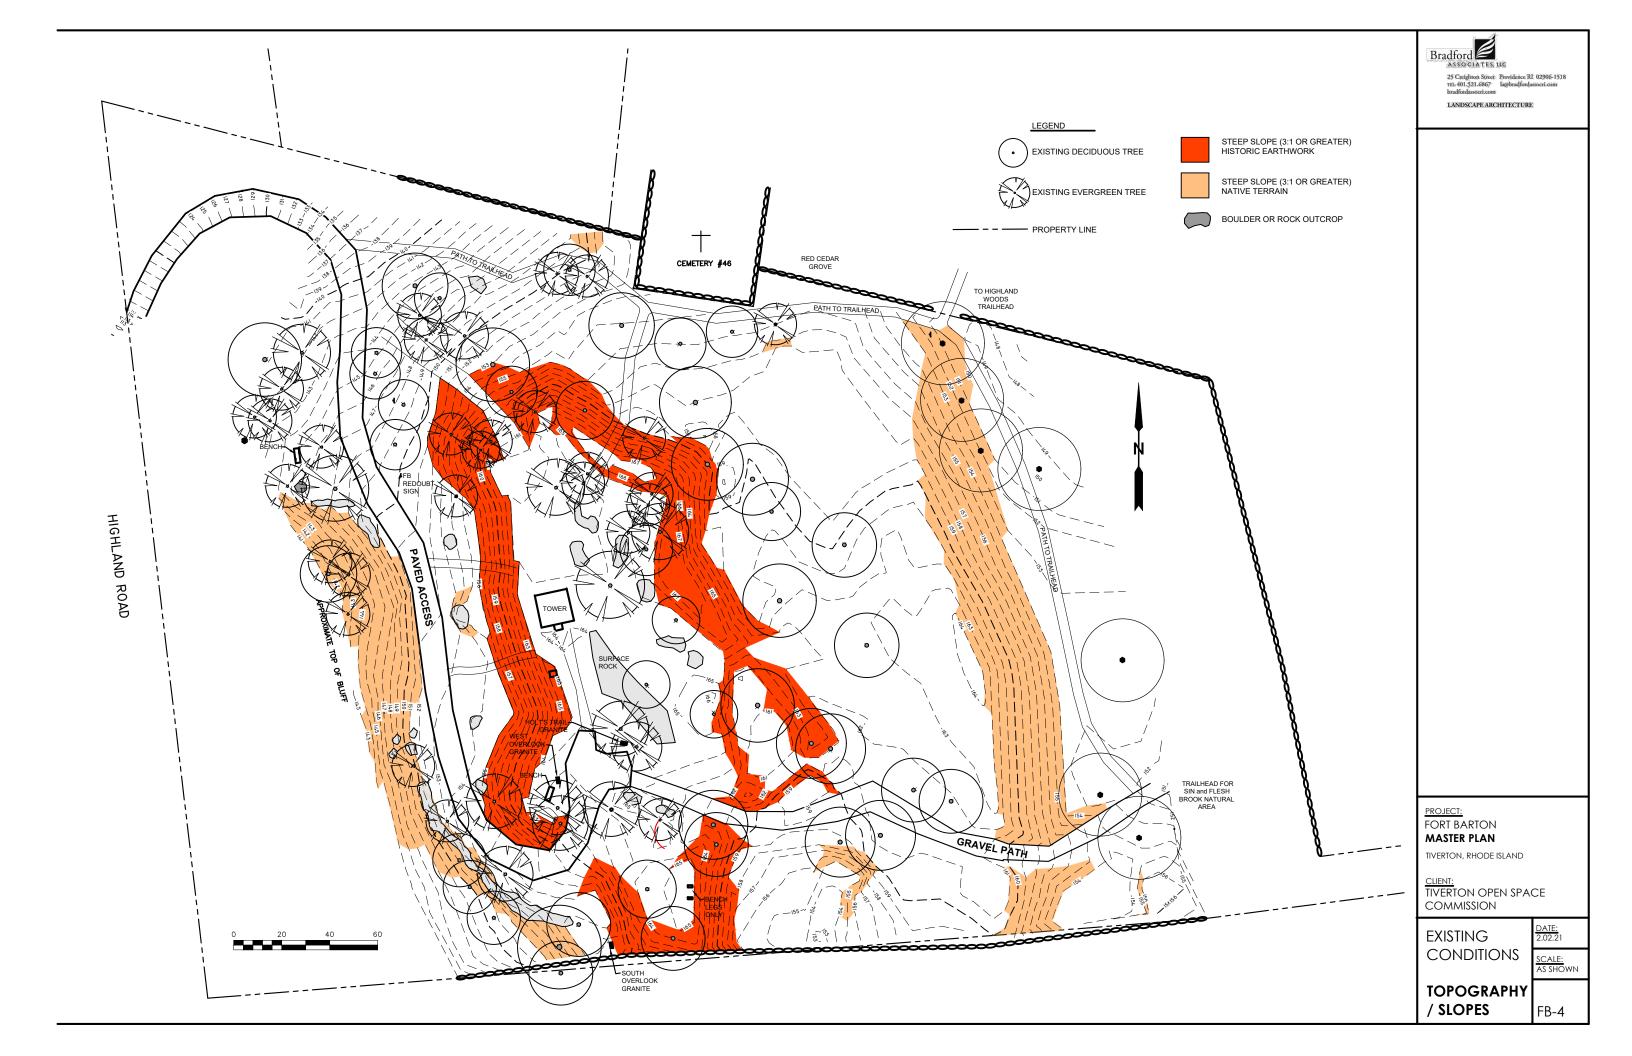
** See Plan 'FB-4 Topography/ Slopes'

Photo: Erosion on the steep slopes from pedestrians and bikes could be the beginning of irreparable damage to the fort slope.

All slopes, both natural and manmade, are vulnerable to disturbance and erosion. Remarkably, however, the redoubt area has remained relatively stable with its protective cover of vegetation. The slopes still provide clear evidence of the early fort location and layout. This makes it all the more important that plans be developed and implemented to preserve this relatively intact Revolutionary War site.

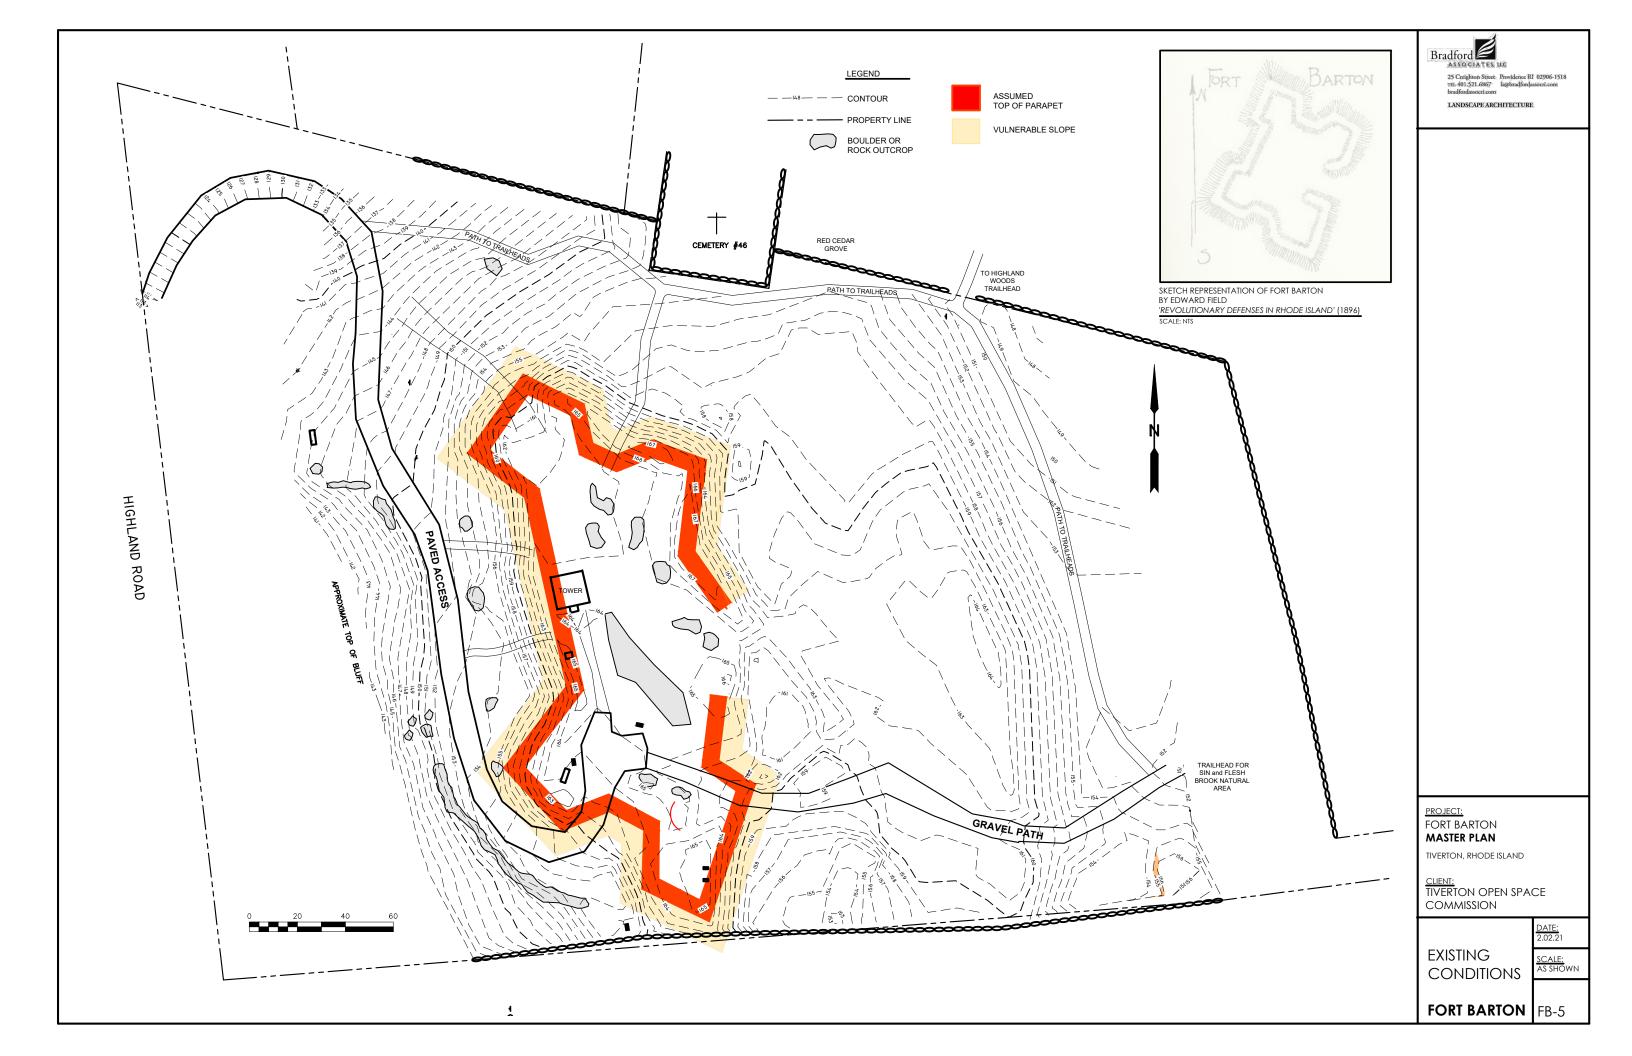
** See Plan 'FB-5 Fort Barton'

Field's diagram superimposed on the existing earthworks topography shows a rough four corners shape in an elongated form, with access from the east. This could be the layout for a conventional fort approximately 200' long by 100' wide.

Even if the specific shape can't be confirmed, the earthworks/parapet remnants should be protected with no additional disturbance, and historical interpretation should include a discussion of this shape with explanations of the southwest driveway and north ramp as later intrusions.

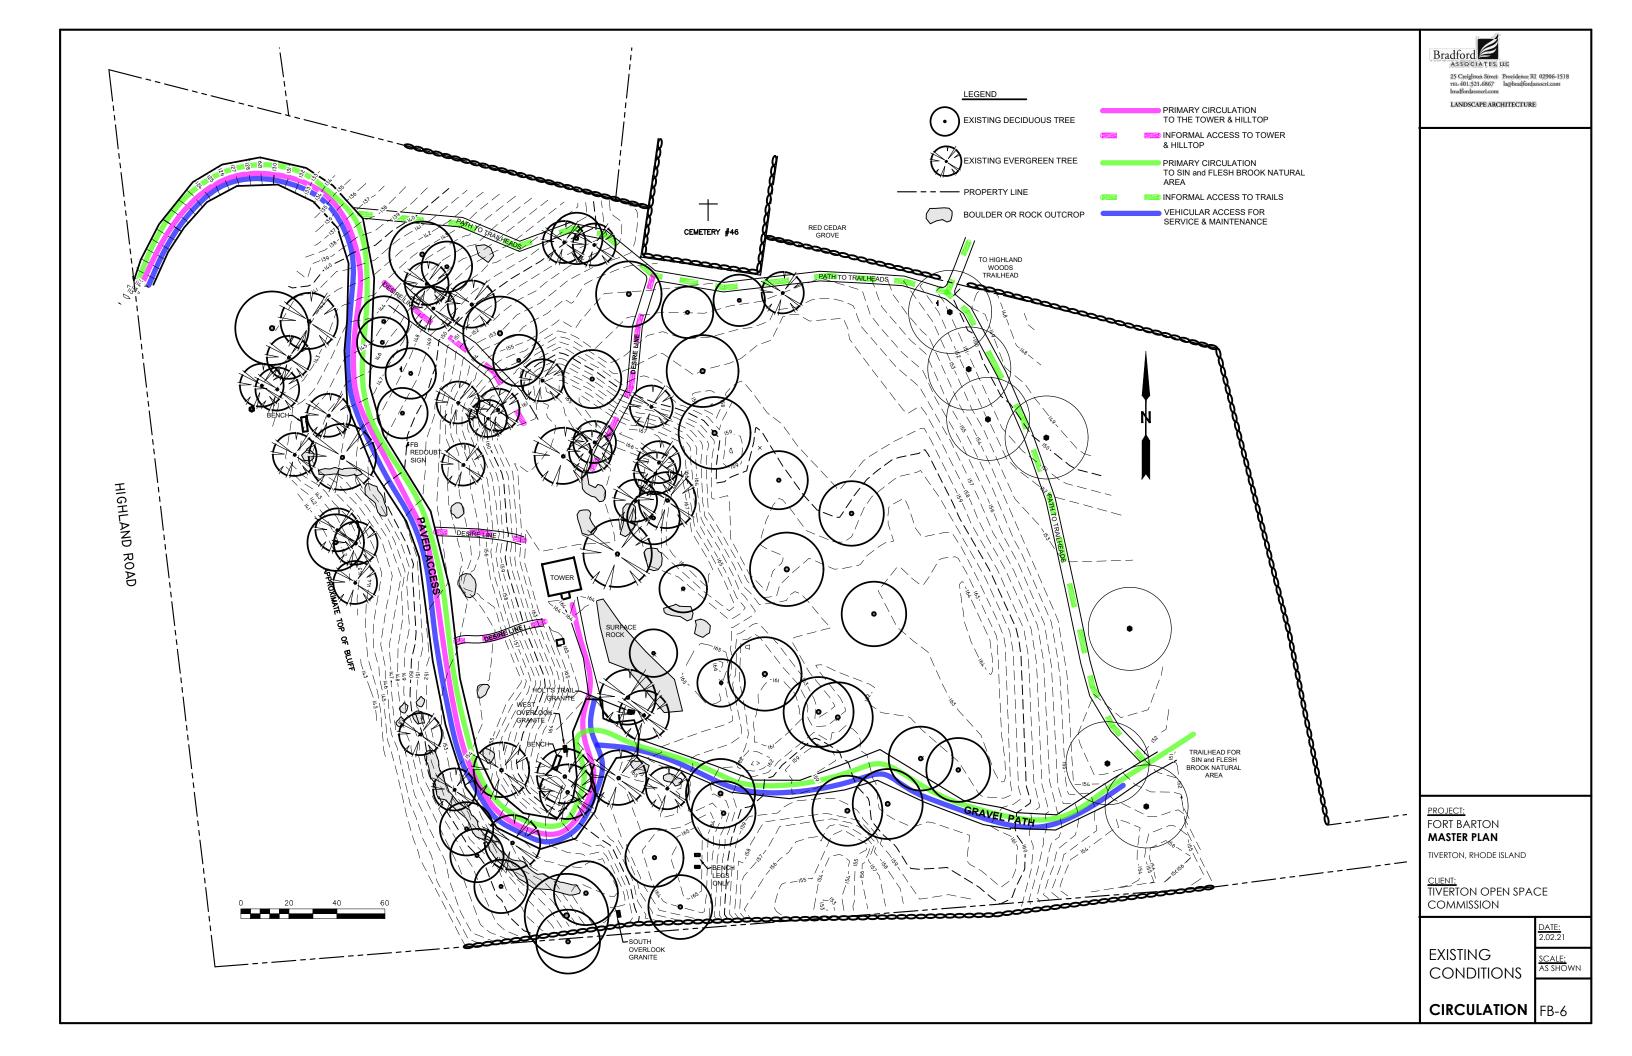
** See Plan 'FB-6 Circulation'

Much of the damage to the earthworks comes from visitors not following the circuitous paved route to the tower, but rather taking "shortcut" climbs up the grass-barrier system. Barriers might keep visitors off the redoubt banks, while maintaining as much as possible its historic character. Additional interpretive signage explaining the fort history could also lead visitors to the best places to understand its layout, construction, and strategic location.

Photo: Eroded desire lines indicate where visitors have climbed over the earthworks to get to the observation tower.

Given the precipitous drop at the edge of the cliff above Highland Road, a site compatible safety barrier would be a desirable element of the circulation plan.

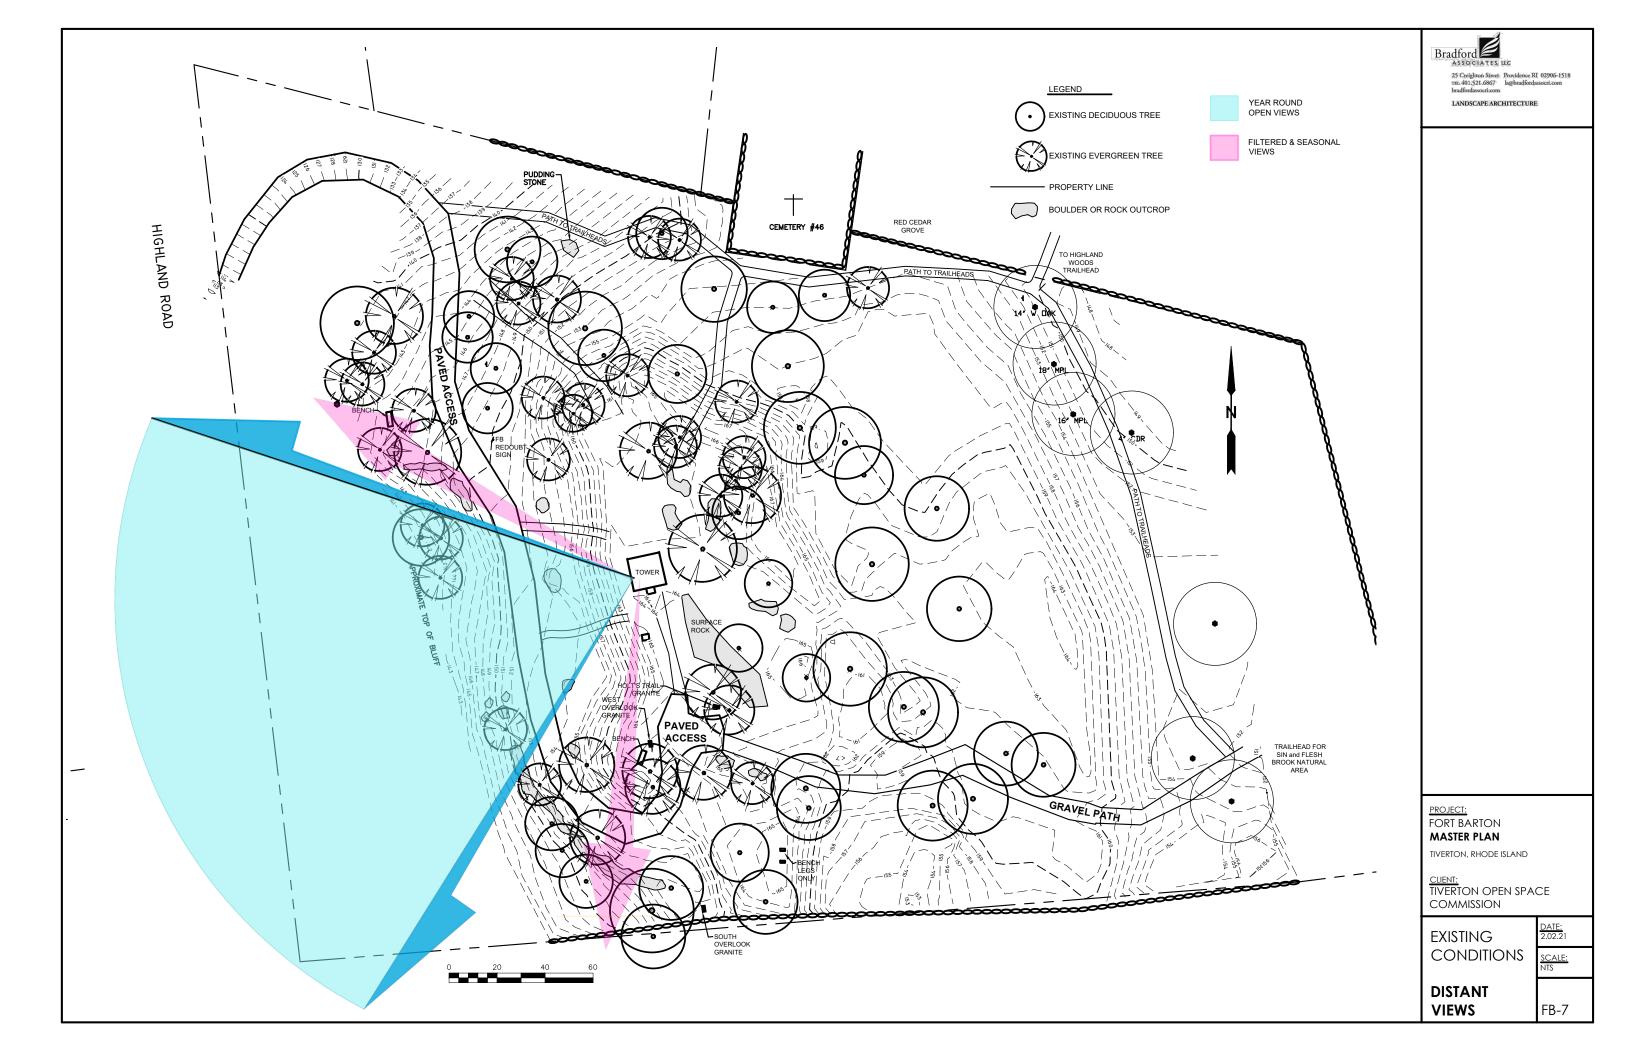
Plan 'FB - 7 Views'

Spectacular views from both the hilltop and observation tower are a main attraction of Fort Barton. They also vividly illustrate the historic strategic value of the site as a commanding position for military defense of the mainland. The entire area was cleared of trees even before the Revolution, so it was completely open in 1776. In recent decades trees have been planted and many appeared naturally. These were allowed to grow to the extent that they now impede much of the horizon.

Fort Barton's location as a prominent high point on the cliff above the Sakonnet River can offer dramatic views of the Sakonnet basin and coastal areas beyond. This is a main attraction of Fort Barton and is important to an understanding of the military significance of both the Revolutionary fort, and to a World War II watchtower that was constructed on site and manned by local citizenry to provide warning of an air attack. Tall trees now restrict what once was a panoramic view, so selective tree removal should be part of the master plan. For the longer term, good park management would include regular tree trimming on the slope above Highland Road, and removal of individual trees that would eventually block critical views.
